RE: Response to NJDEP Ecological Component Review Comments  
Hatco Corporation, PI No. G000003943  
Comment Receipt Date: August 30, 2016

Licensed Site Remediation Professional (LSRP) Mark Fisher and Weston received comments on the ecological components of the Remedial Investigation Report (RIR) for the Hatco site, dated May 7, 2016. New Jersey Department of Environmental Protection's (NJDEP) comments were presented in an undated memorandum from Nancy Hamill to Matthew Turner and Gerald Hahn of the Bureau of Inspection and Review. Weston and the LSRP of Record for the Site respectfully provide this letter responding to each comment. Each of NJDEP's comments is reproduced below followed by the associated response.

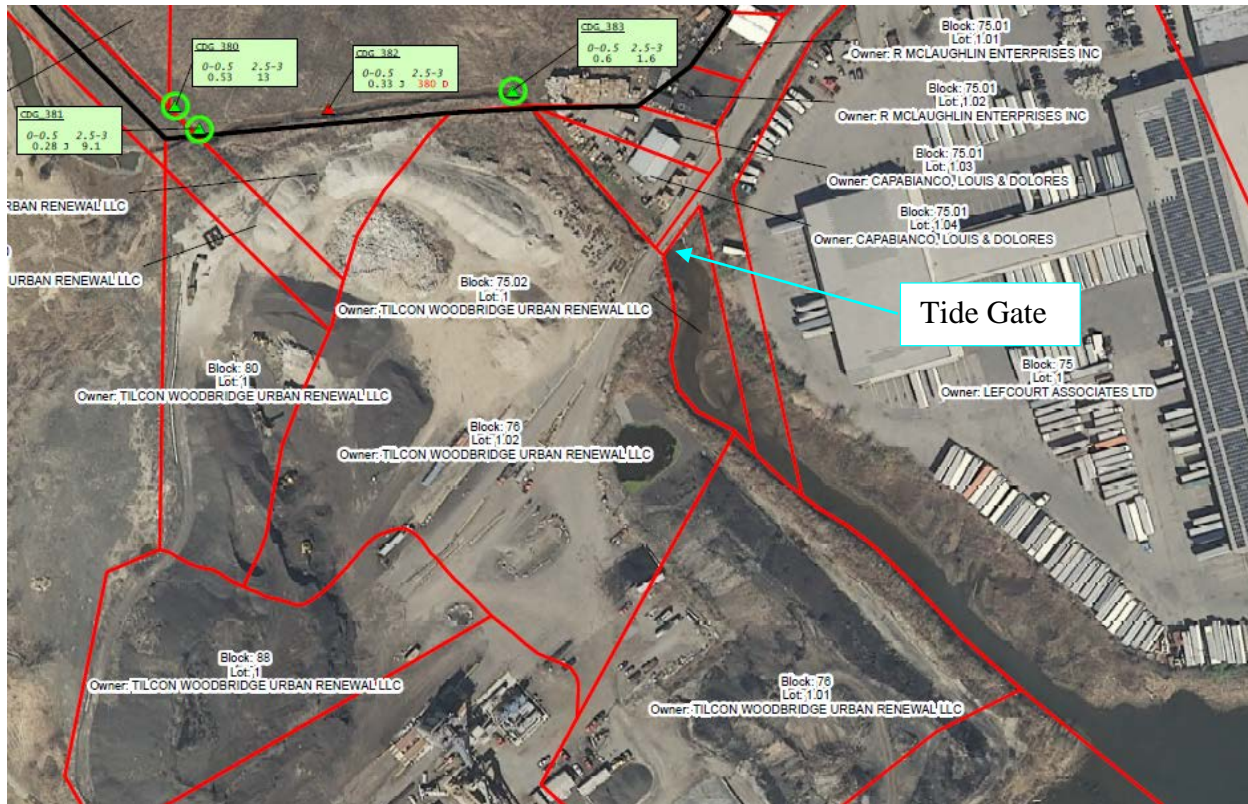
Additionally, it is important to note that a tide gate is located in Crows Mill Creek, roughly 300 feet downstream from this location, which separates the lower 700 feet of the creek from the rest of the channel. The tidal effect downstream of the tide gate allows flow in both directions along the lower 700 feet of the creek, to and from the river. There are numerous known contaminated sites along the Raritan River upstream from this area. Sediments in this lower reach would be expected to reflect conditions from multiple sources not related to Hatco. As discussed above and presented in the RIR, the existing data indicate that sediment contamination has been delineated

more than 1,000 feet upstream of the river. Without evidence to indicate downstream impacts from Hatco, it is not appropriate to extend the sampling beyond this limit. The detail below, from RIR figure 7.1.15-3 has been annotated to show the location of the tide gate.

**Response 1B:** NJDEP comments that “Data collection in the lower 1000’ section of Crows Mill Creek, at the confluence of Crows Mill Creek with the Raritan River, and proximal locations in the Raritan River is required.” As noted above, sediment sampling in Crows Mill Creek demonstrated delineation of potential site-related contaminants upstream of the tide gate and therefore, no further investigation is warranted regarding this issue.
